L. White Company
Property Inspection Report

1234 Anywhere Ave, My Town, CA 93274
Inspection prepared for: Sample Report
Date of Inspection: 4/24/2014 Time: 4:00
Age of Home: 29 years Size: 2034
Weather: Clear

Report Summary

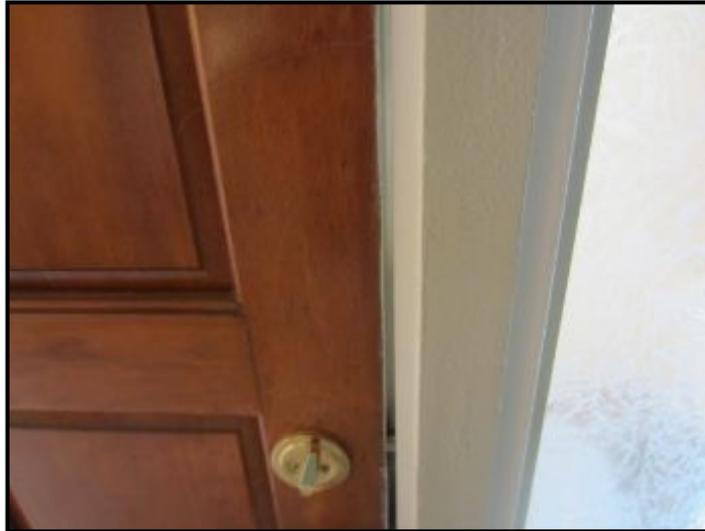
Weatherstripping is not sealing at most exterior doors

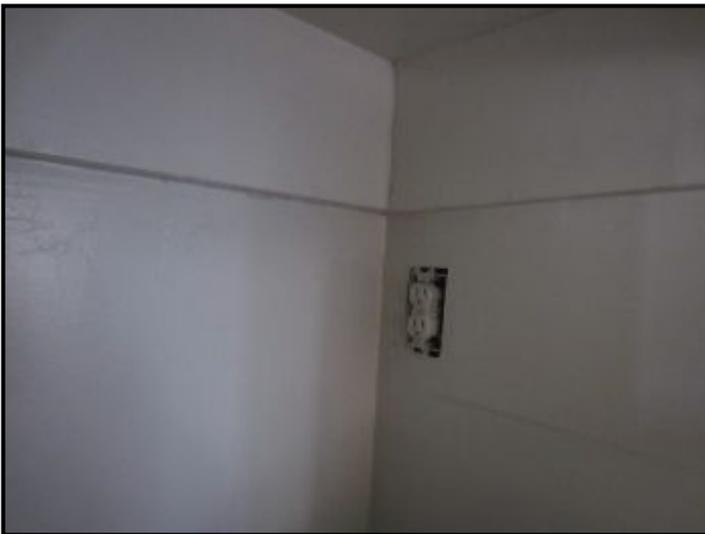
Outlet cover plates missing. Under stairs

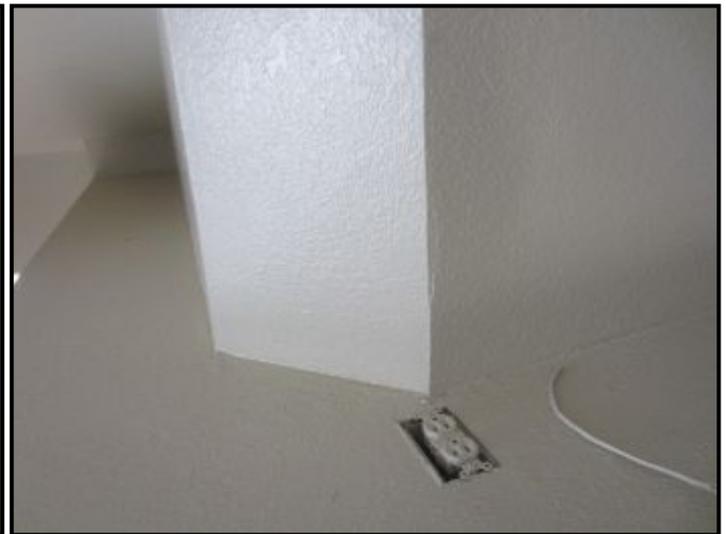
Outlet cover plates missing. plant shelf in living room

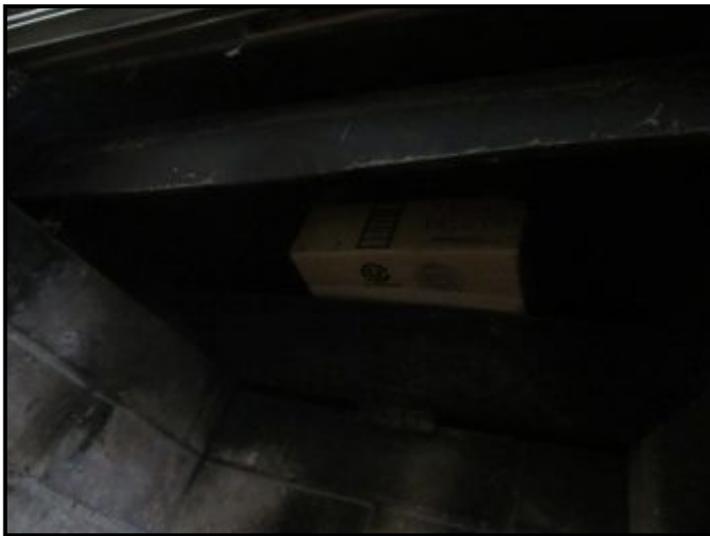
There is a cardboard box inserted below the damper apparently in an attempt to keep the damper closed. Strongly recommend that a qualified chimney sweep evaluate/repair before this unit is used.

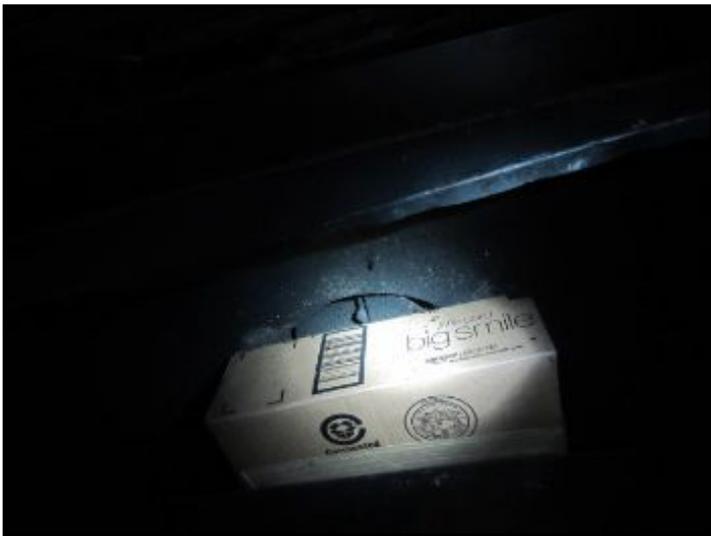
There is a cardboard box inserted below the damper apparently in an attempt to keep the damper closed. Strongly recommend that a qualified chimney sweep evaluate/repair before this unit is used.

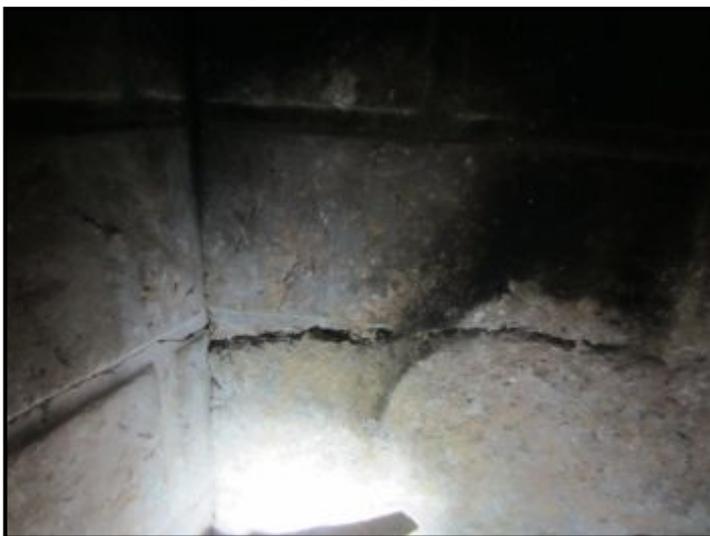
Small cracks present.

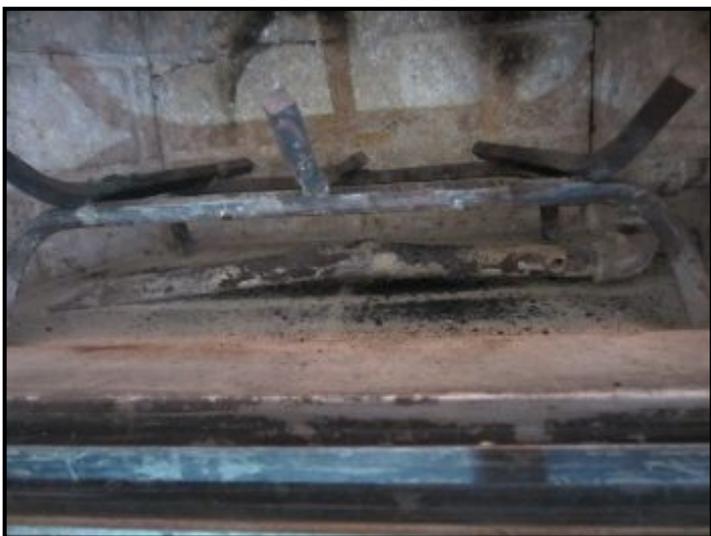
Gas log lighter is damaged and should be repaired/replaced prior to using.

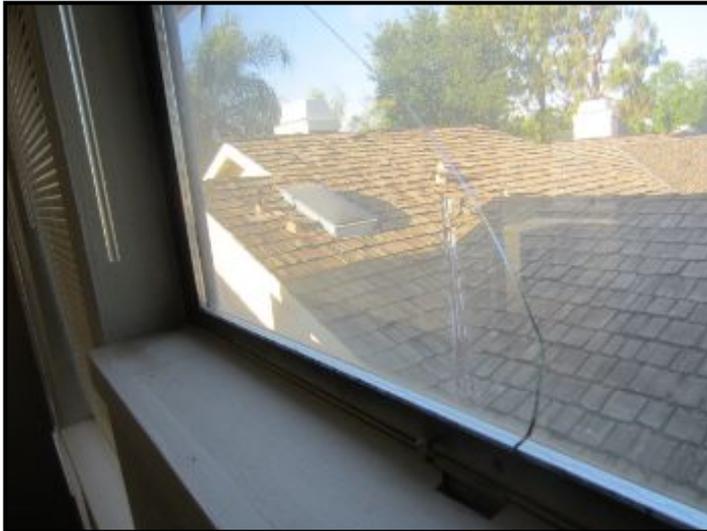
Broken glass on stairway window

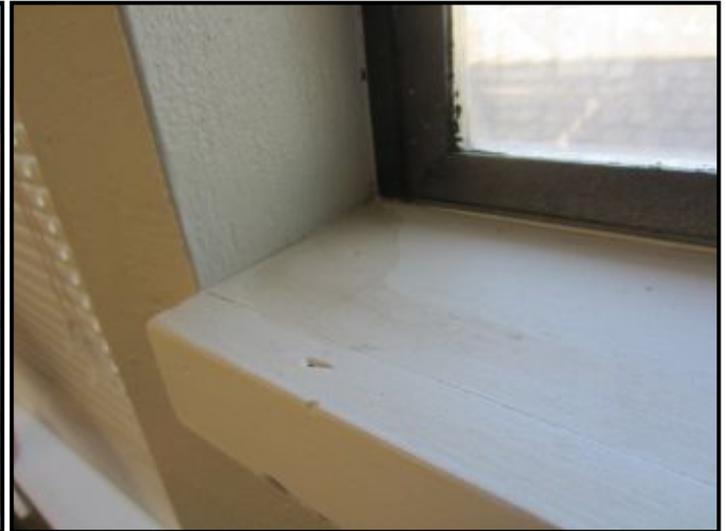
Evidence of past leaking on window sills @ stairway windows

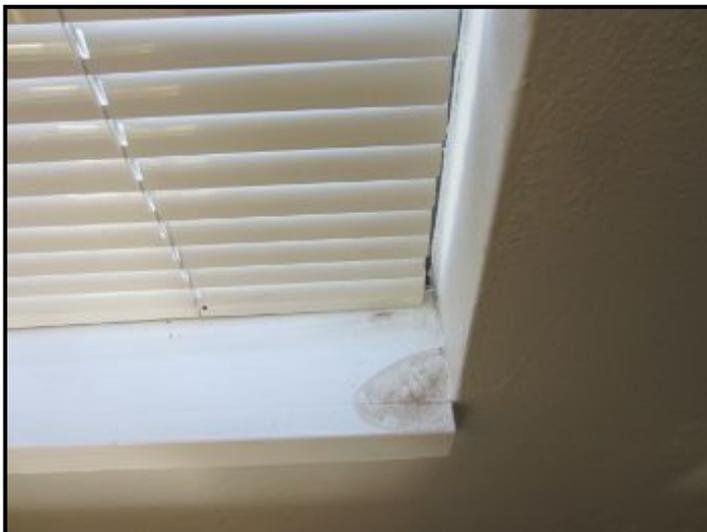
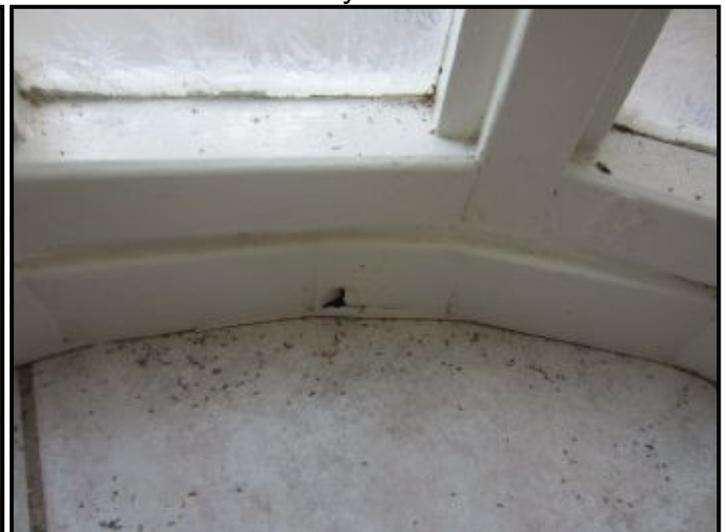
Deterioration of wooden frames noted. While basic maintenance may prolong the life of these window frames, replacement may be necessary at some point.

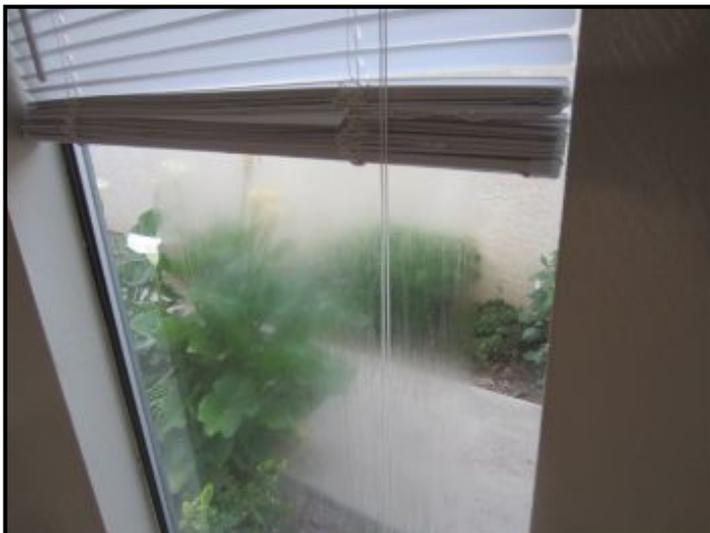
One or more window/s shows sign of loss of seal/condensation, recommend repair or replace to provide energy savings and prevent hazed window from limiting view out of window.

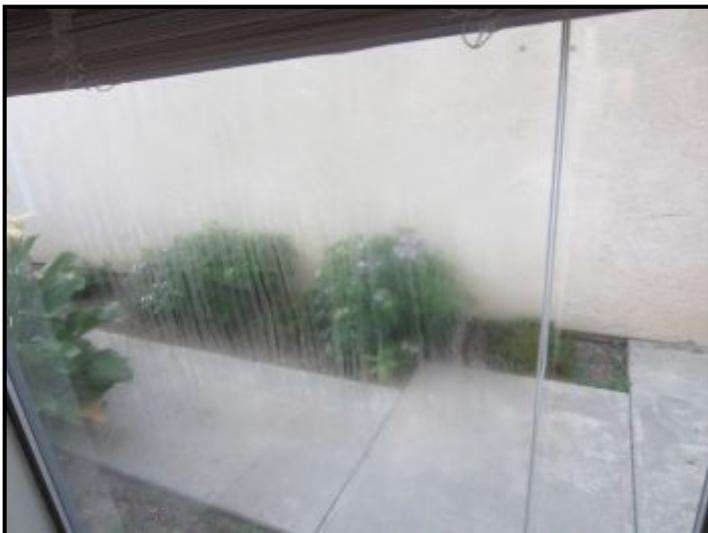
One or more window/s shows sign of loss of seal/condensation, recommend repair or replace to provide energy savings and prevent hazed window from limiting view out of window.

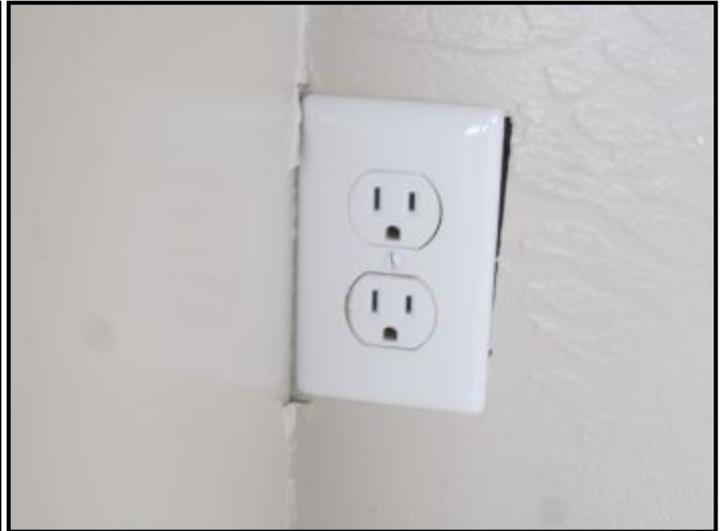
gap at receptacles

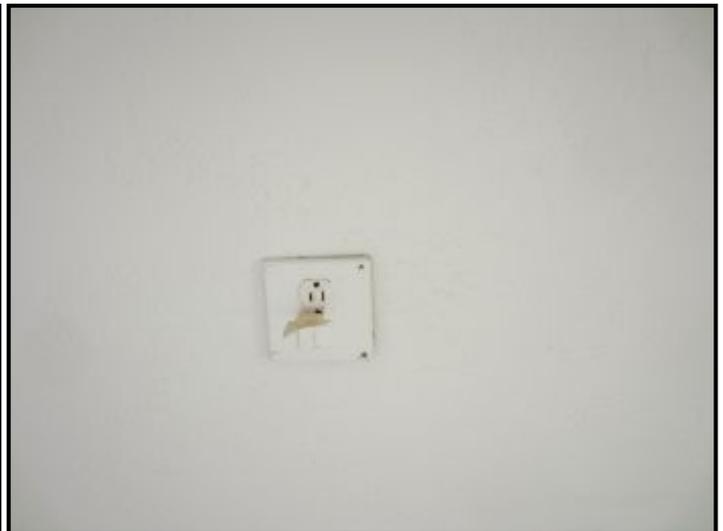
Bedroom #5 electrical on ceiling

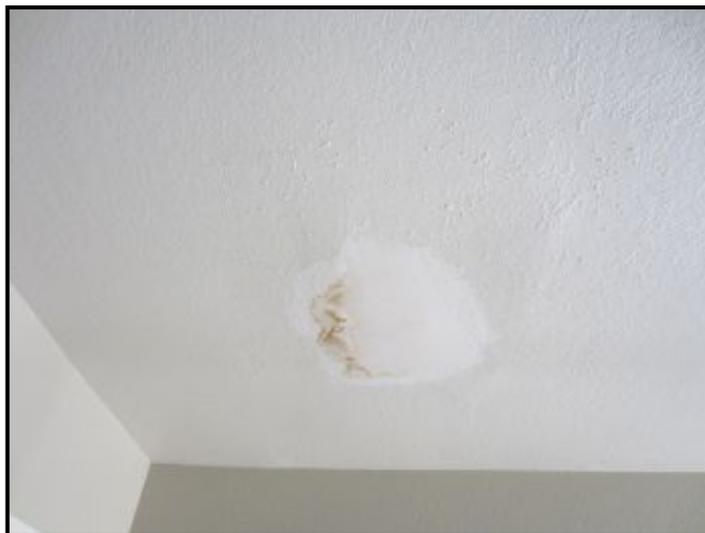
Evidence of past leaking was noted.

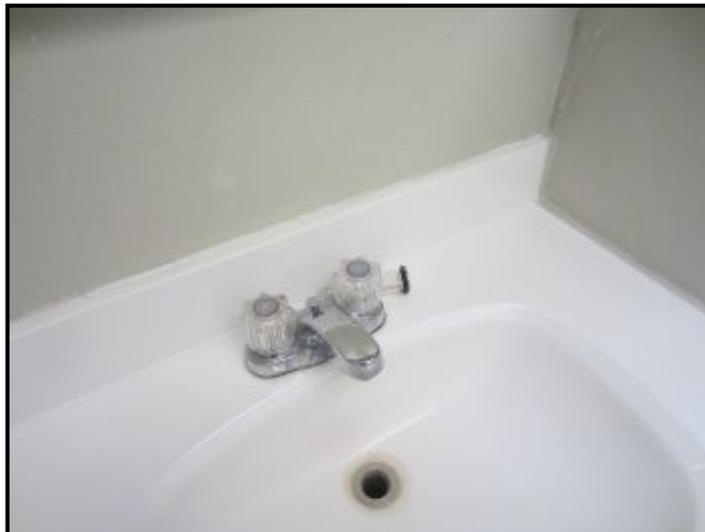
Stopper is missing/inoperable.

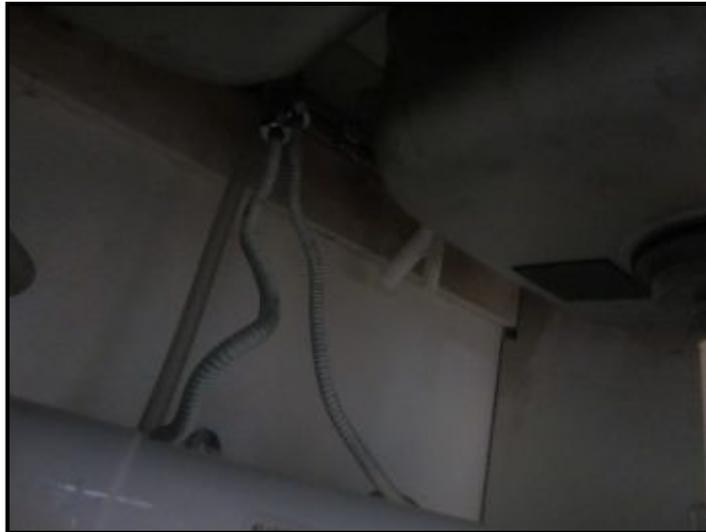
Lack of a proper air gap noted at dishwasher drain line. In the event of a sewer backup this device prevents sewer matter from entering into dishwasher. Recommend having a qualified plumber install a air gap to prevent possible contamination.

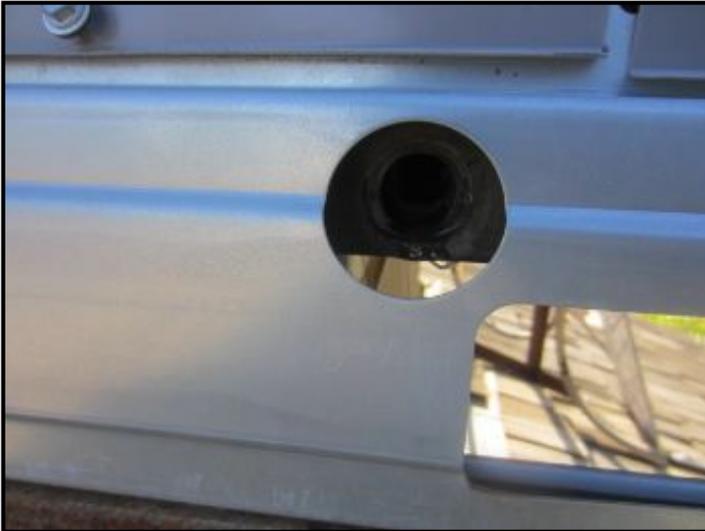
Condensate lines are missing from both roof-top dual pack units, draining condensate onto roofing. This will reduce the life of the roofing and create potential roof leaks. Recommend having a qualified HVAC contractor evaluate and repair.

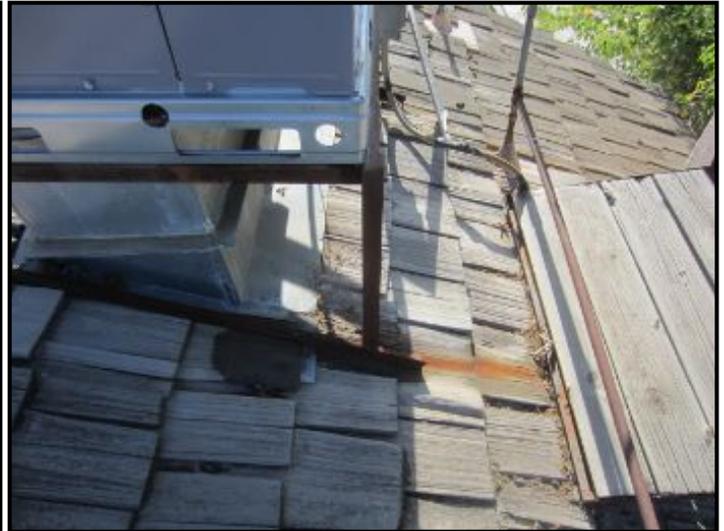
Condensate lines are missing from both roof-top dual pack units, draining condensate onto roofing. This will reduce the life of the roofing and create potential roof leaks. Recommend having a qualified HVAC contractor evaluate and repair.

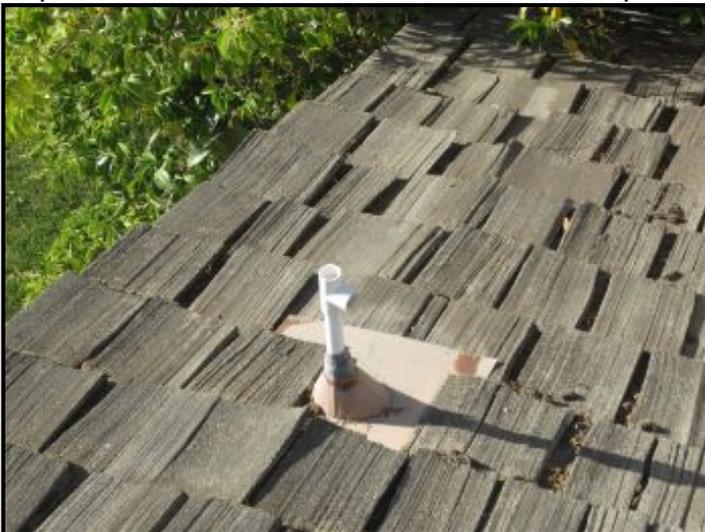
Condensate lines are missing from both roof-top dual pack units, draining condensate onto roofing. This will reduce the life of the roofing and create potential roof leaks. Recommend having a qualified HVAC contractor evaluate and repair.

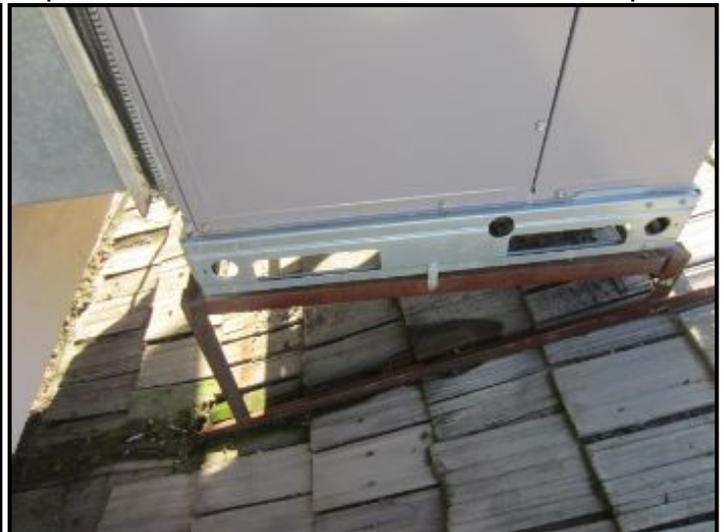
Condensate lines are missing from both roof-top dual pack units, draining condensate onto roofing. This will reduce the life of the roofing and create potential roof leaks. Recommend having a qualified HVAC contractor evaluate and repair.

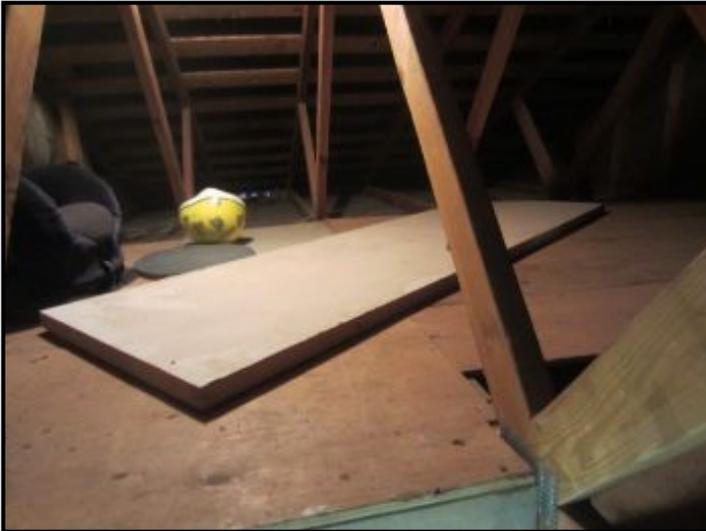
Garage attic is not engineered for storage.

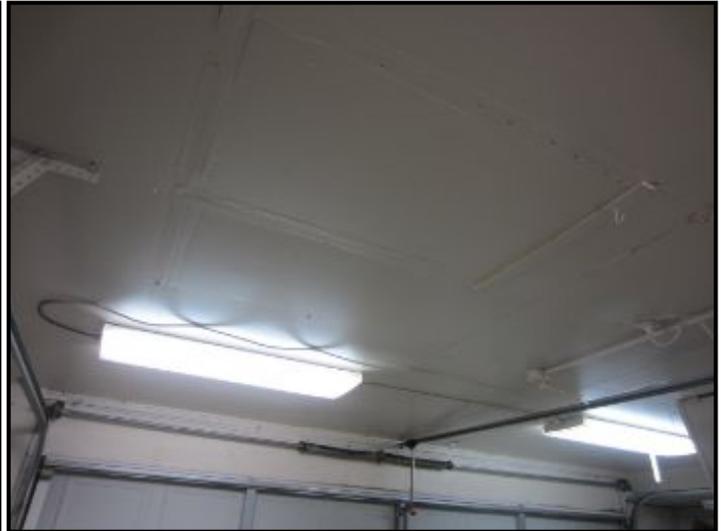
Garage drywall ceiling needs to be properly repaired.

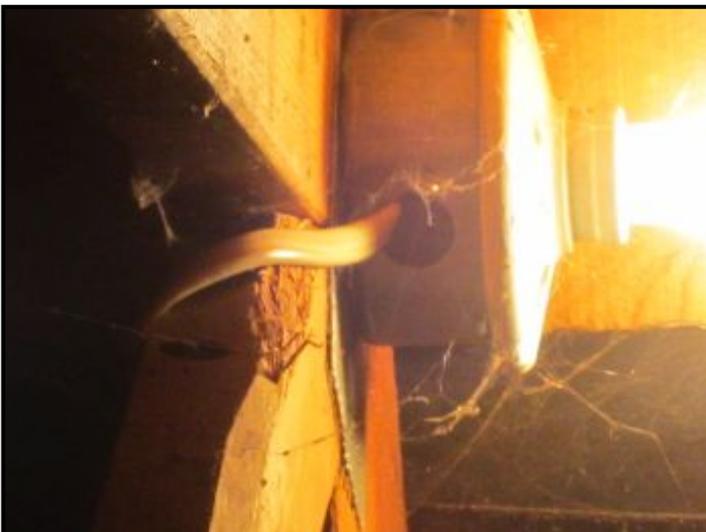
Attic switch and light boxes both have romex wiring with no connectors to metal boxes. Recommend having a qualified electrician make proper connections.

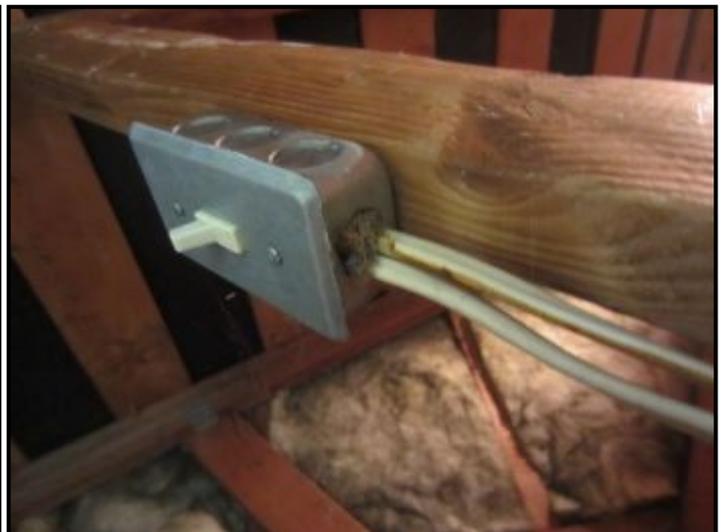
Attic switch and light boxes both have romex wiring with no connectors to metal boxes. Recommend having a qualified electrician make proper connections.

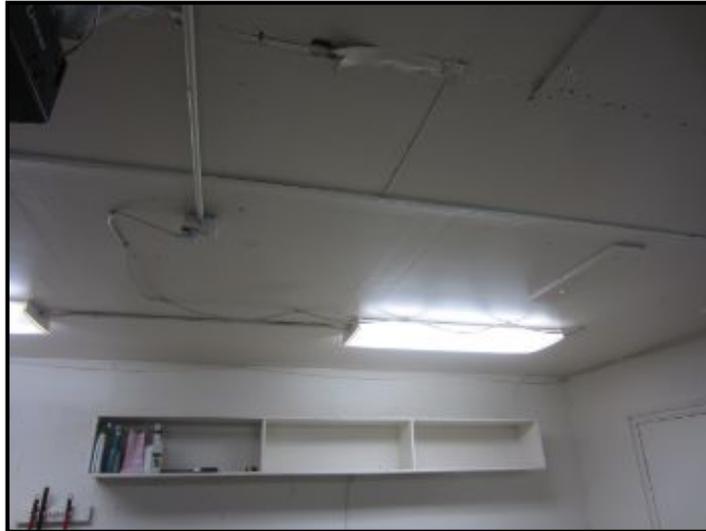
Surface mounted fluorescent lights have been wired with cord & plug. Recommend hard wiring per acceptable standards.

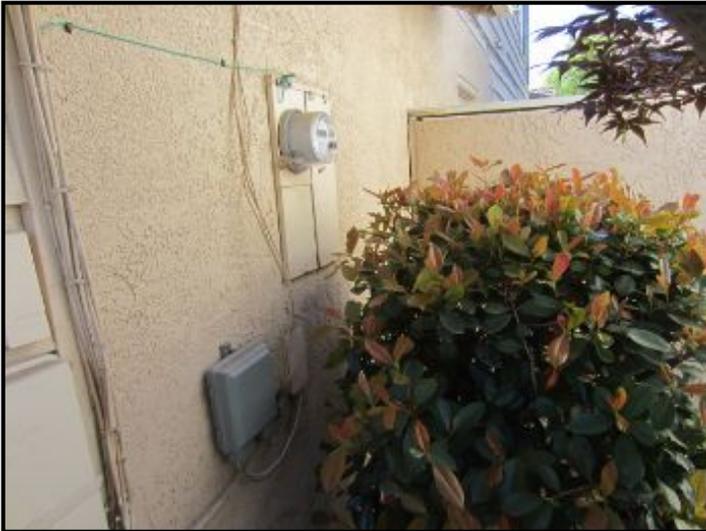
Area 3' in front of electrical panels should be kept clear for access

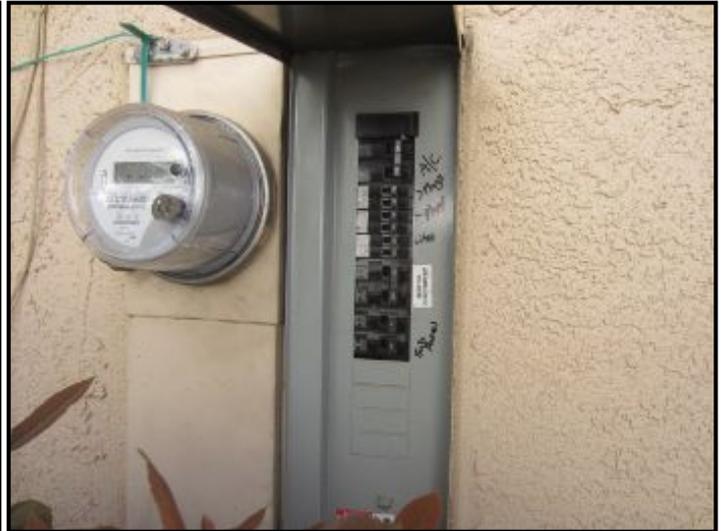
Main Electrical Panel cover does not appear to be the original cover and does not fit well inside panel. Gaps are present at side of breakers. Recommend having a qualified electrician evaluate and repair.

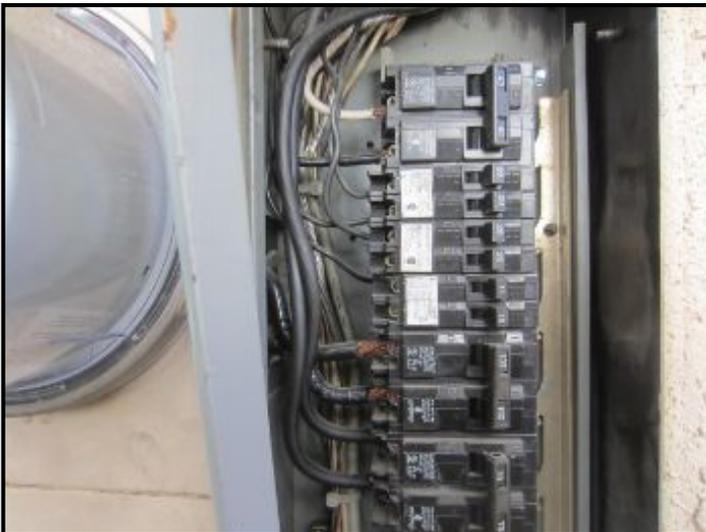
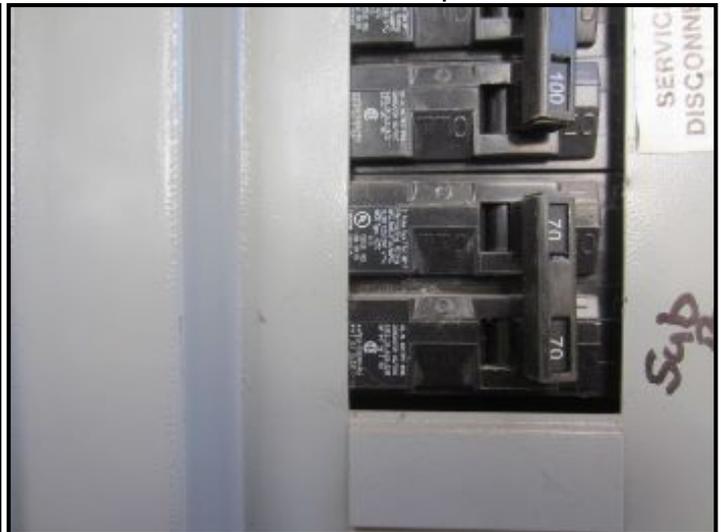
Main Electrical Panel cover does not appear to be the original cover and does not fit well inside panel. Gaps are present at side of breakers. Recommend having a qualified electrician evaluate and repair.

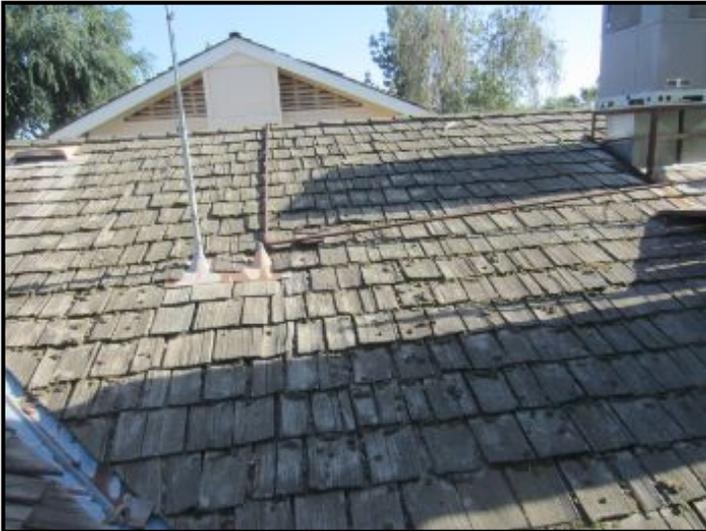
Wood shake roof is beyond functional lifespan. Recommend replacing the roof.

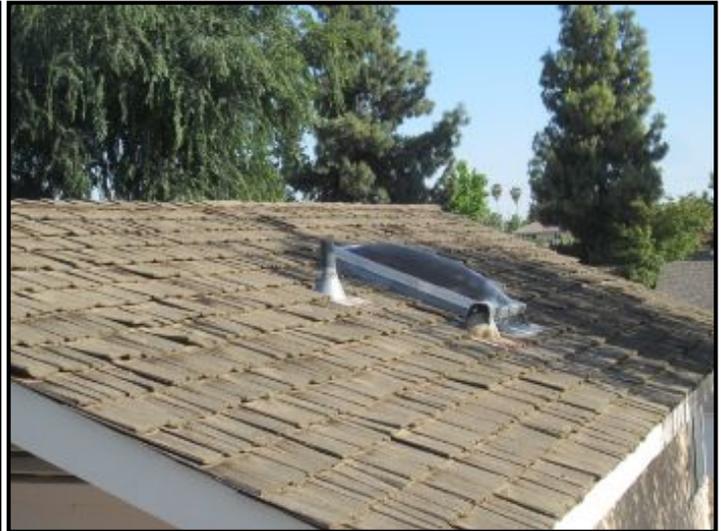
Some wood shakes missing / damaged / nails lifting.

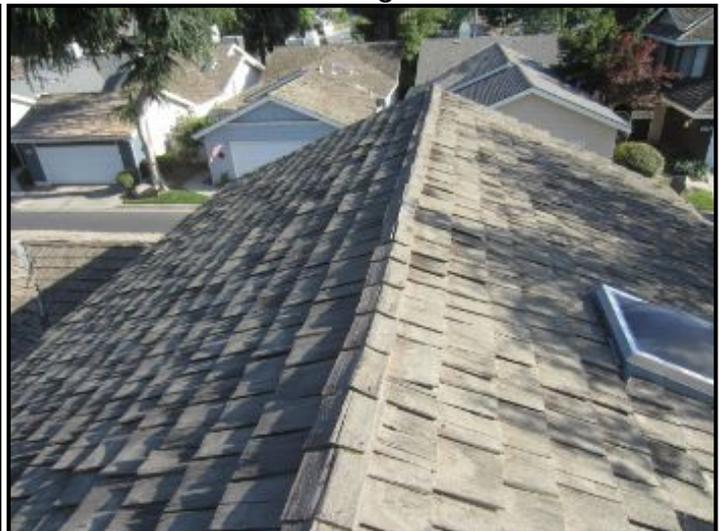
Some wood shakes missing / damaged / nails lifting.

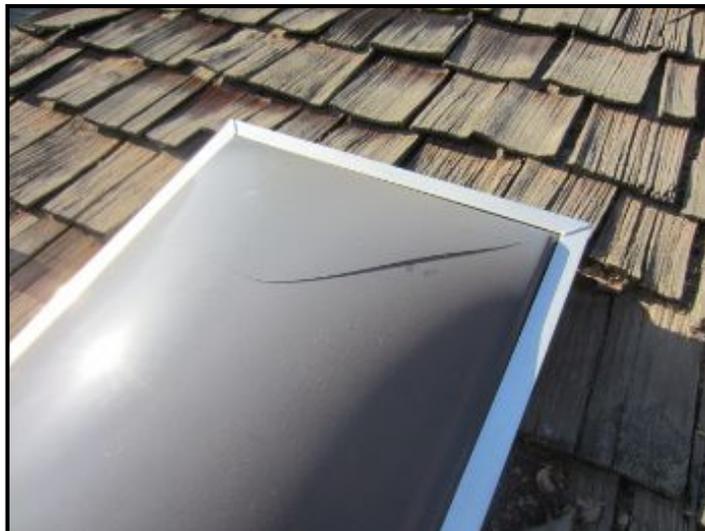
The sky light is past its serviceable life time and shows signs of excessive leaking, have it replaced/repared by a qualified individual.

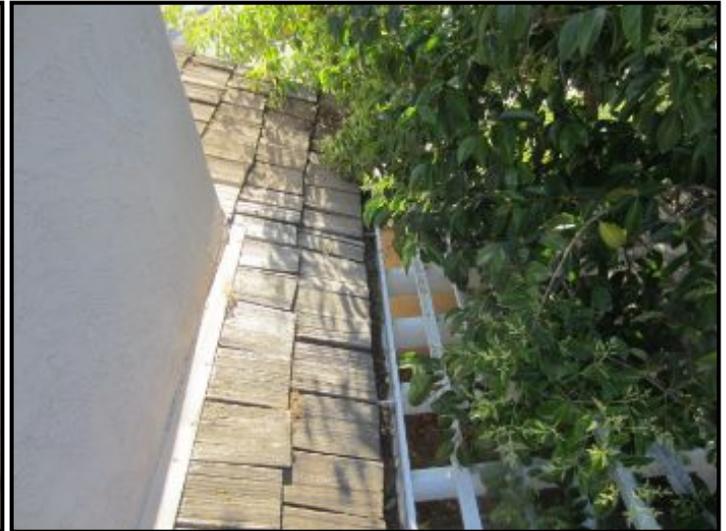
Clean gutters: Significant amounts of debris
evident.

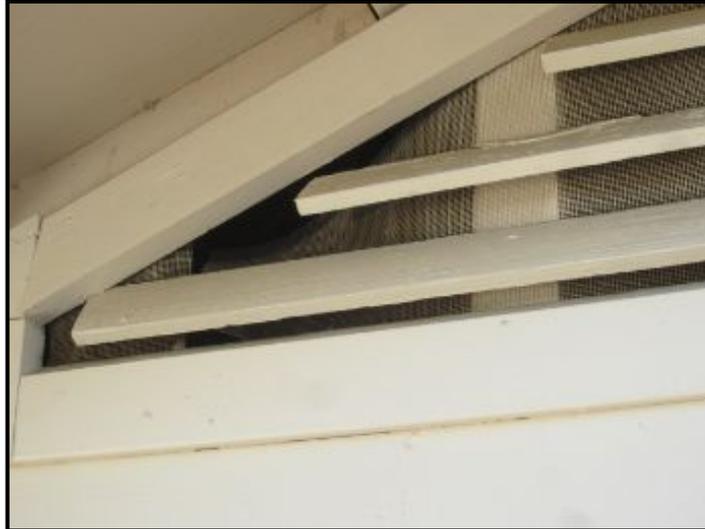
Vent screens are damaged or missing, suggest repairing or replacing screens as necessary.

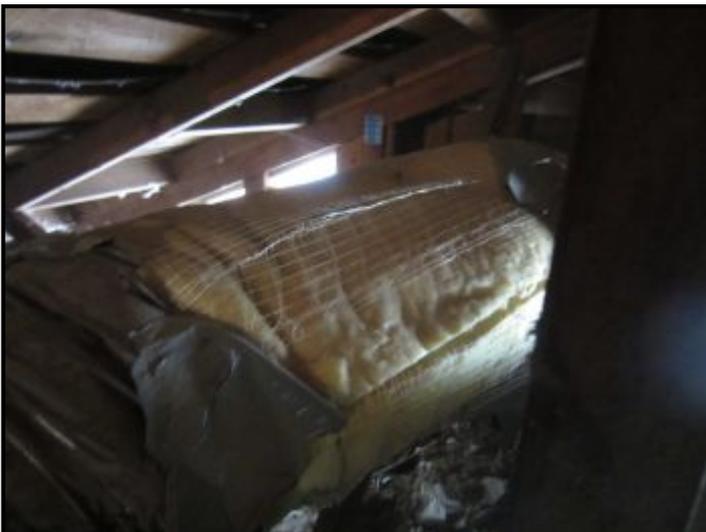
Wrapping is torn in areas.

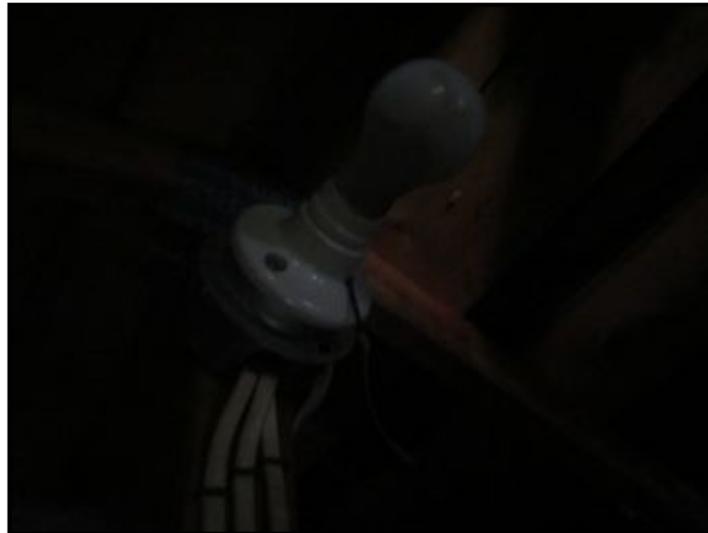
pull chain light not operable in upstairs attic

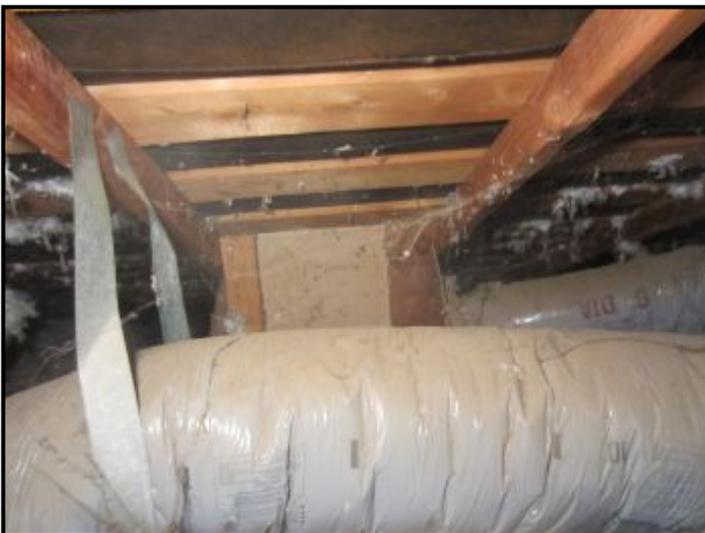
Missing insulation at skylight shafts

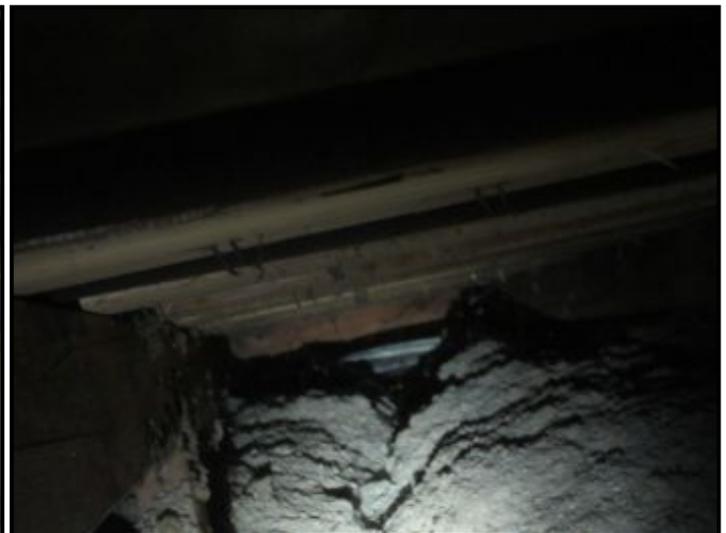
Insulation that is settled does not perform to the R-Value that it once did.

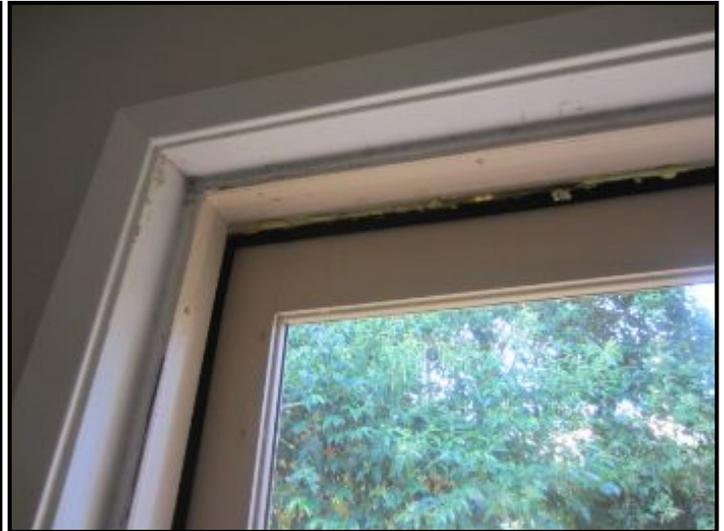
Doors do not seal well. this can be an energy drain.

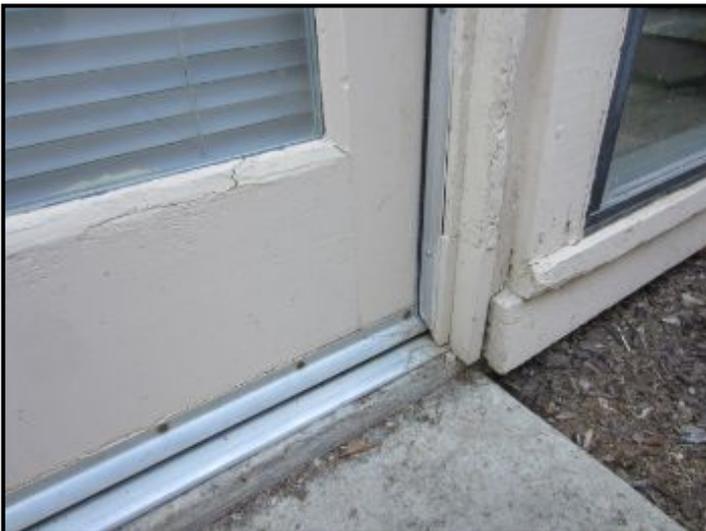
Wood deterioration observed at east door out of living room. Suggest repairs/replacement as needed.

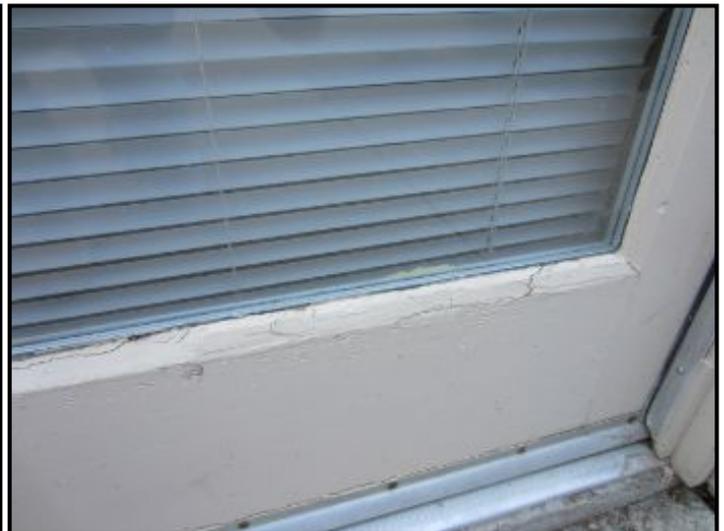
Wood deterioration observed at east door out of living room. Suggest repairs/replacement as needed.

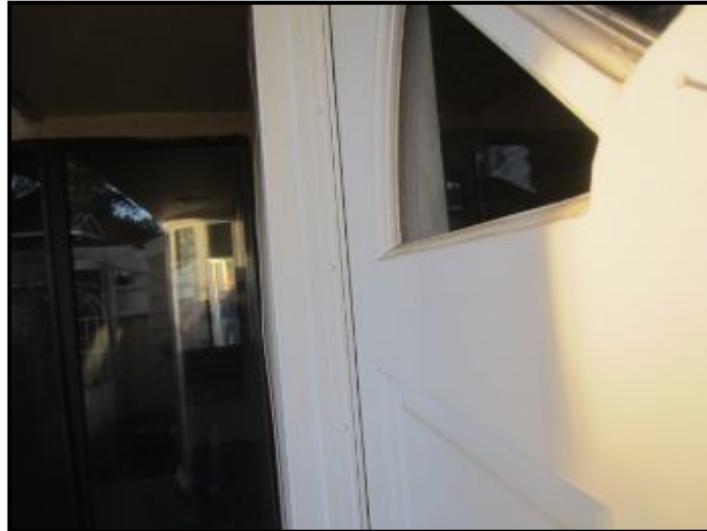
Doors do not seal well. this can be an energy drain.

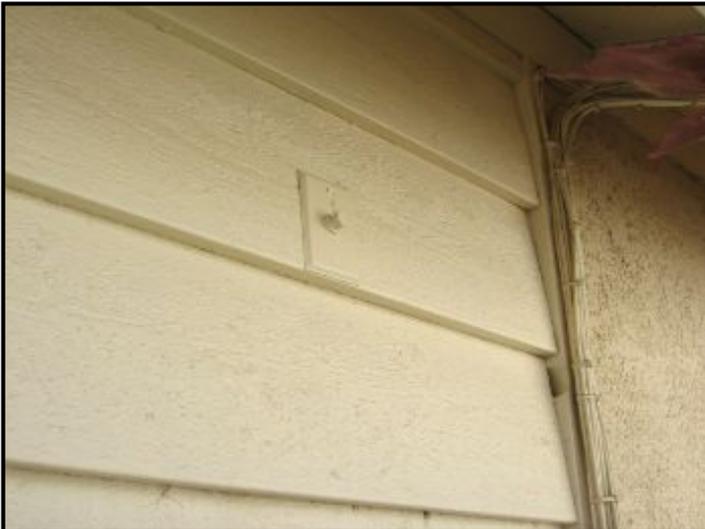
Photo sensor is painted over

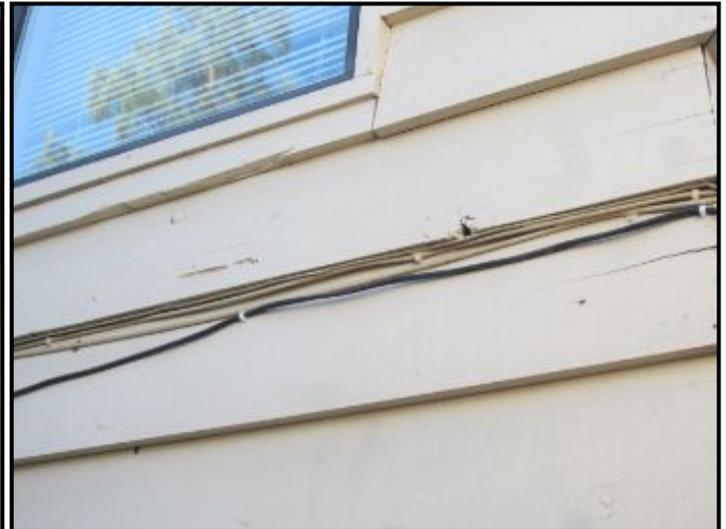
Natural wood siding has some knot holes. Consider caulking or, at the very least, monitoring for the presence of insects, bird damage, or other activity.

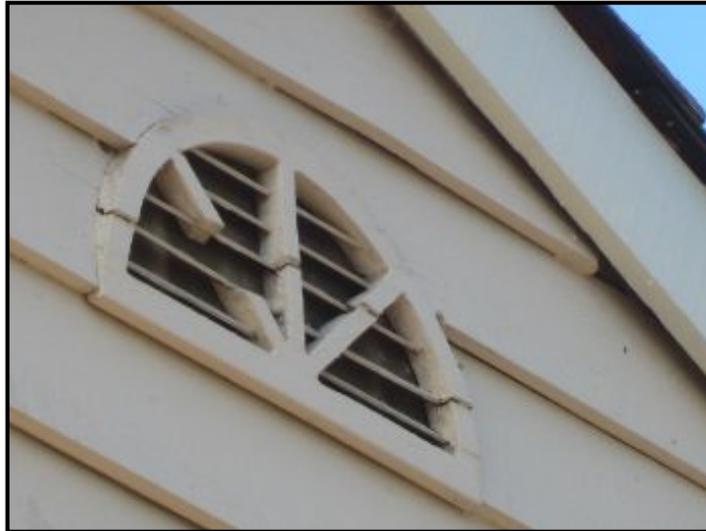
Broken trim on gable vent

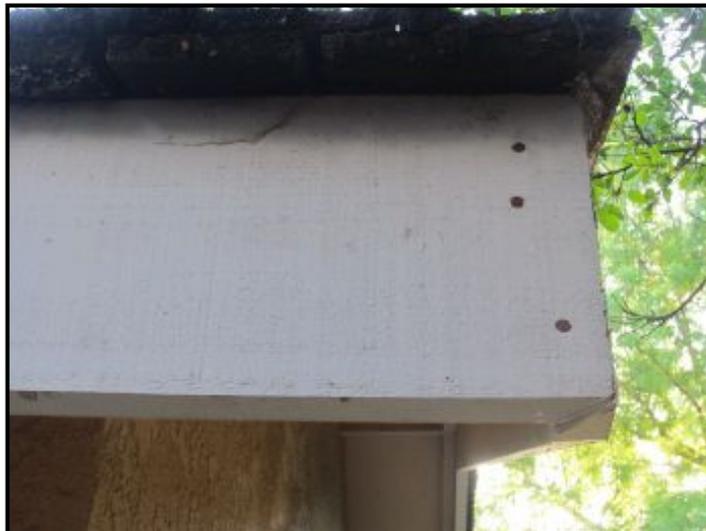
Fascia at northeast corner of house has been replaced recently, but non-galvanized nails were used to attach it. These nails will rust and stain the paint finish. Recommend removing the GV sinker nails, and re-nail fascia with hot-dipped galvanized nails or screws.

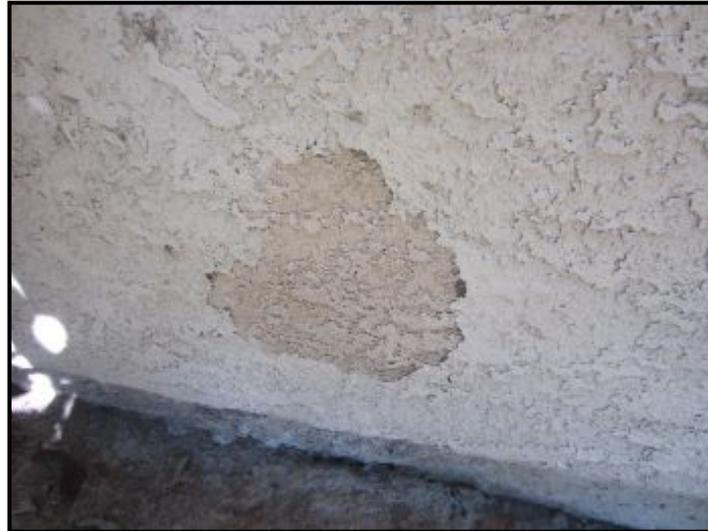
There are a few holes and cracks in the stucco. There is a small area on the west wall that the paint finish is peeling. Recommend monitoring and repairing as necessary

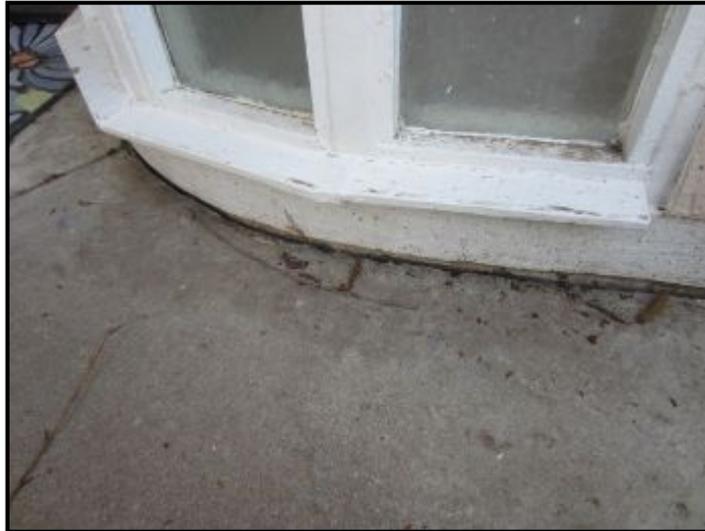
Front sidewalk settling away from house under entry door windows. Monitor for additional movement.

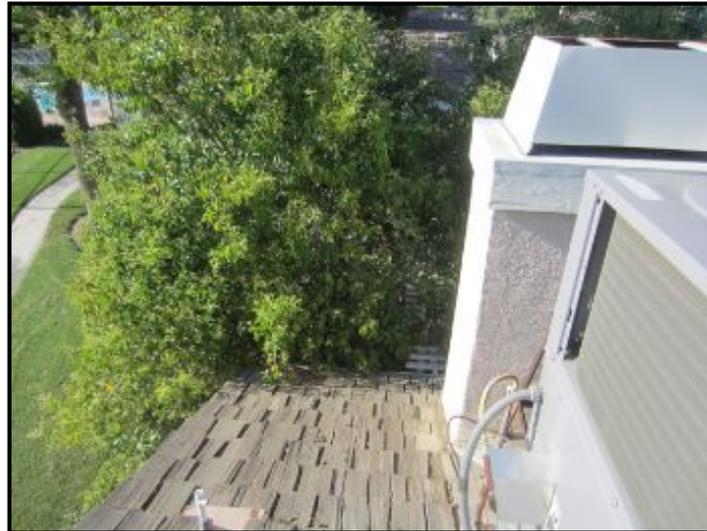
Tree limbs within 10 feet of roof should be trimmed away to provide air and sunlight to roof, while minimizing debris & dampness.

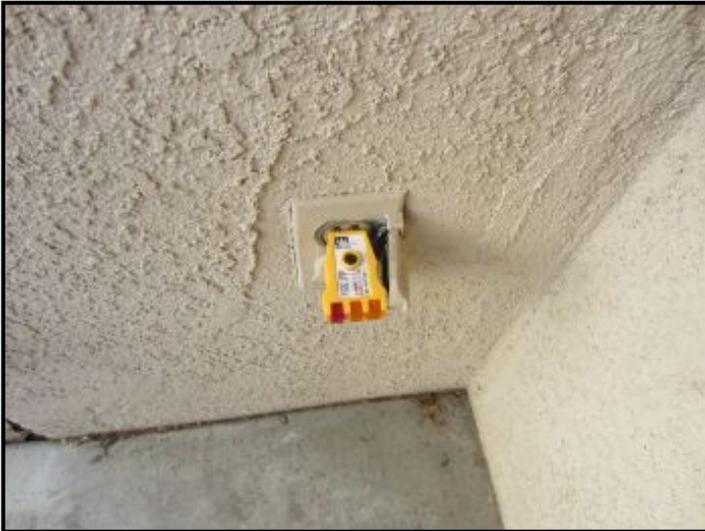
East patio outlet not GFCI protected

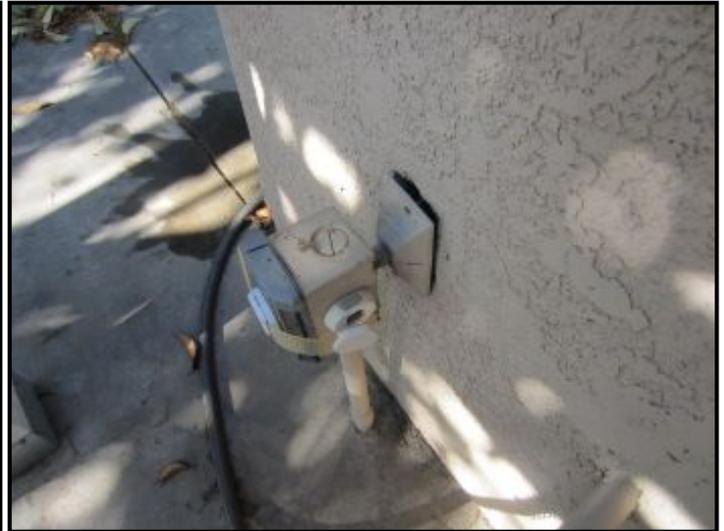
Outlet damaged or apparently inoperable.

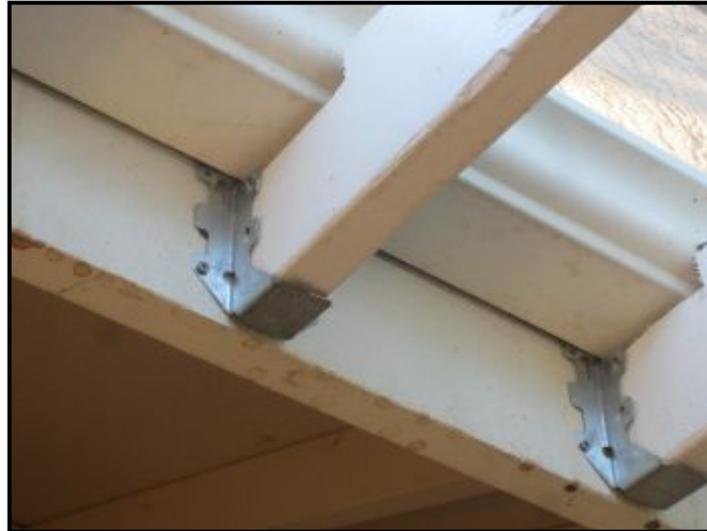
The rafters of the lattice patio cover are attached to the house fascia with screws from the back side. There has been an attempt to fit the rafters with joist hangers, but the proper fasteners have not been used. Recommend having a qualified contractor complete the installation of joist hangers using the proper fasteners.

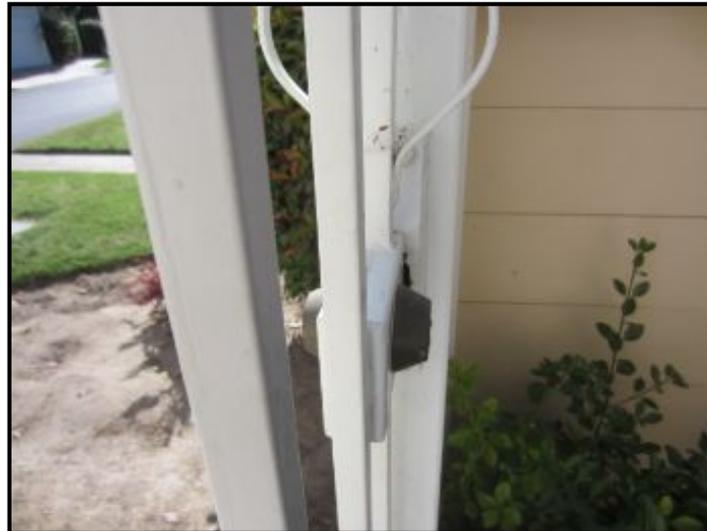
Double cylinder lock on front gate does not provide adequate emergency egress
