L. White Company
Property Inspection Report

1234 Anywhere Ave, My Town, CA 93274
Inspection prepared for: Sample Report
Date of Inspection: 4/24/2014 Time: 4:00
Age of Home: 29 years Size: 2034
Weather: Clear

Report Summary

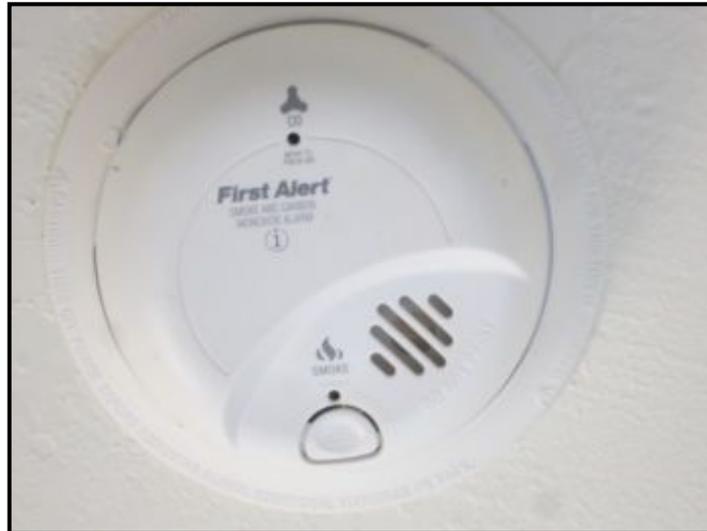
Operated when tested.

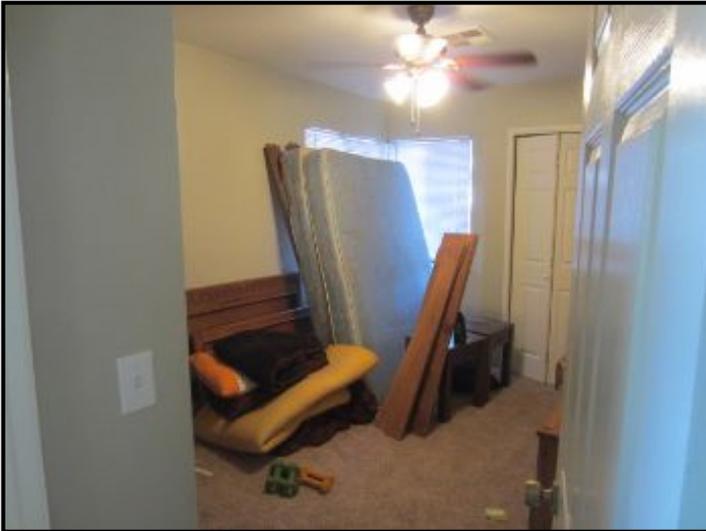
Some outlets not accessible due to furniture and or stored personal items.

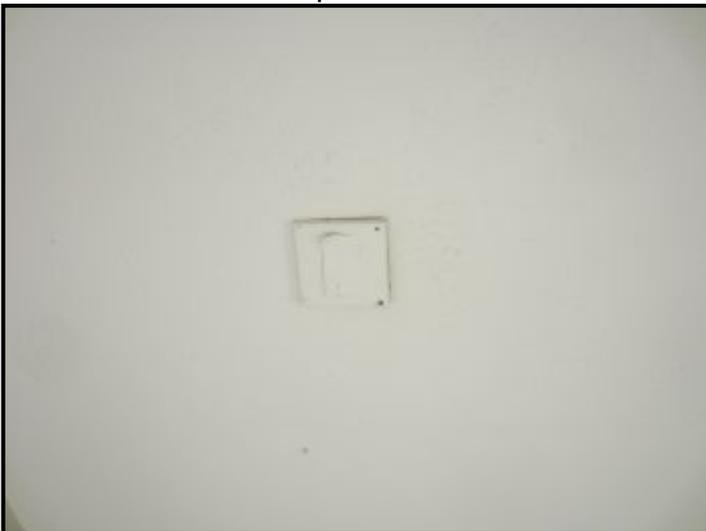
Bedroom #5 electrical on ceiling

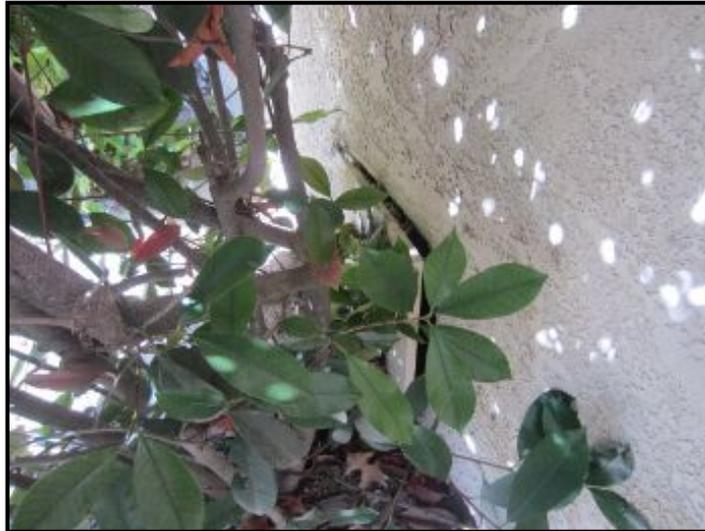
Tub access panel obscured by bush

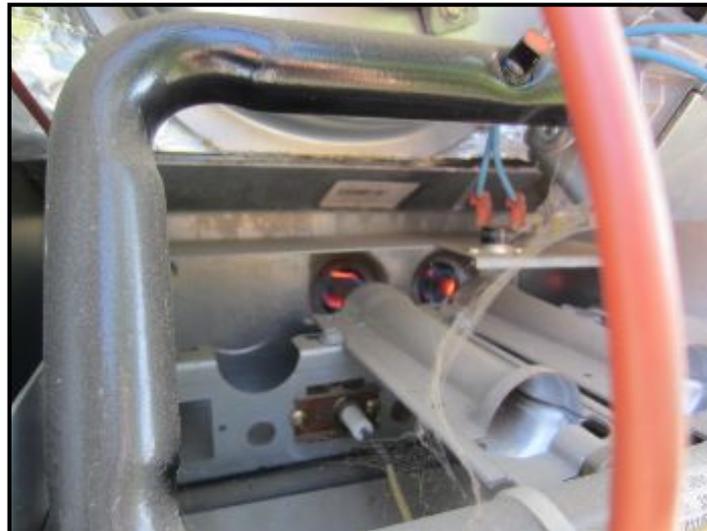
Appears functional at time of inspection.

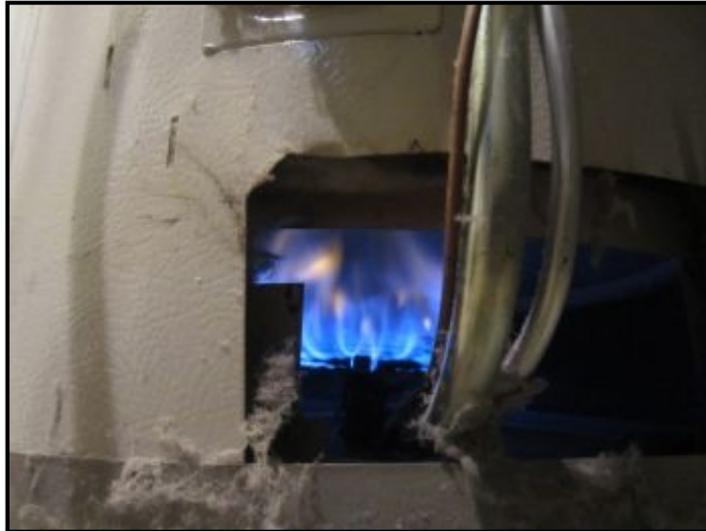
The combustion chamber appears to be in functional condition.

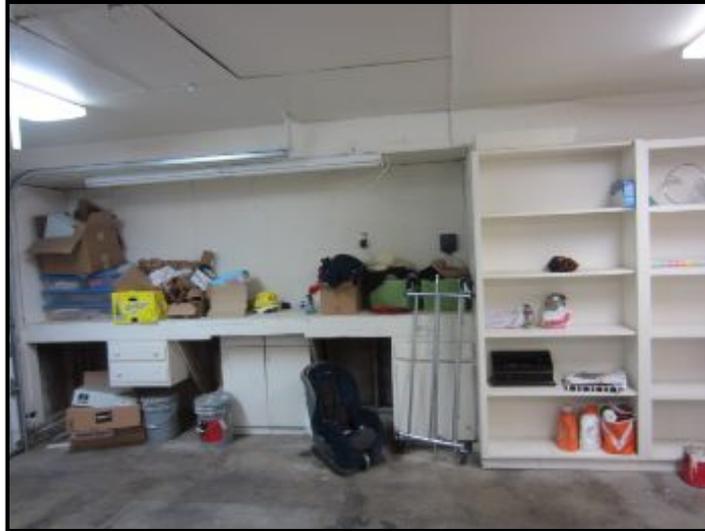
Personal items in garage block complete inspection of all floor, wall and ceiling areas.

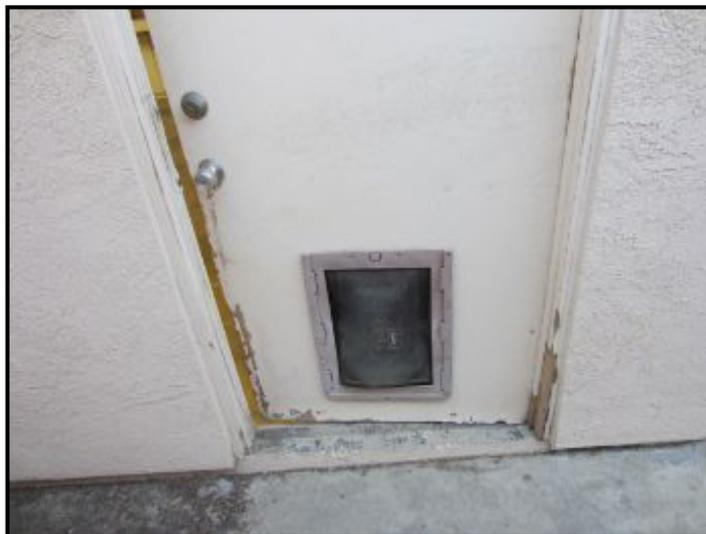
Exterior door is extremely weathered.

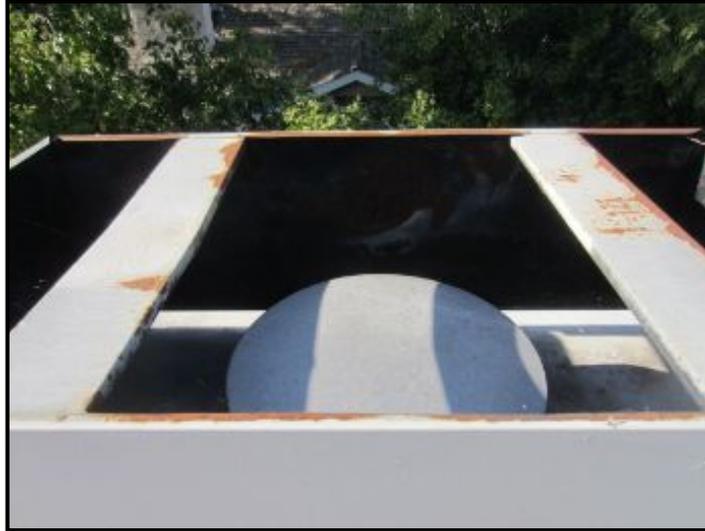
No major system safety or function concerns noted at time of inspection.

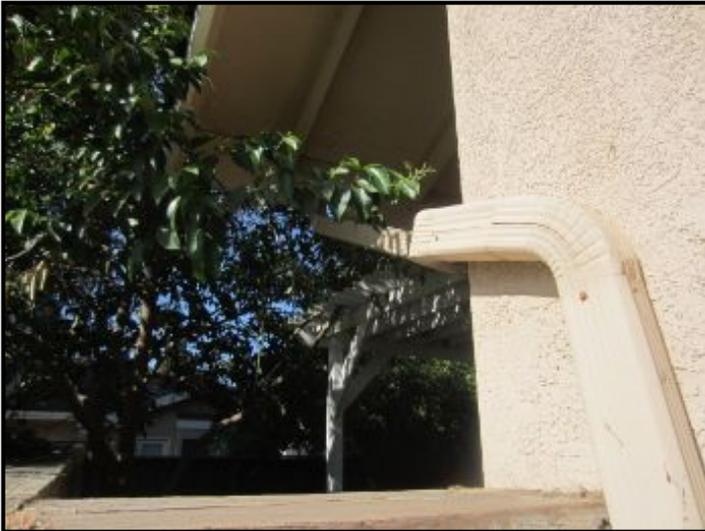
Downspouts pulling away from the house;
resecure as needed.

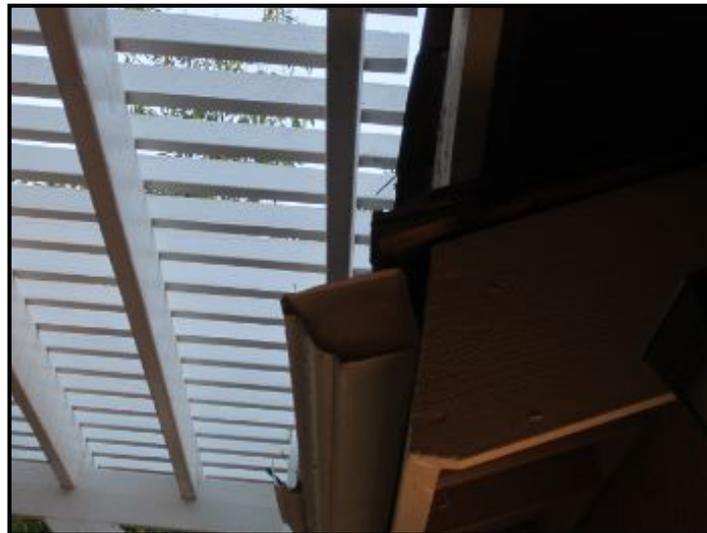
North west patio gutter hanging away from fascia

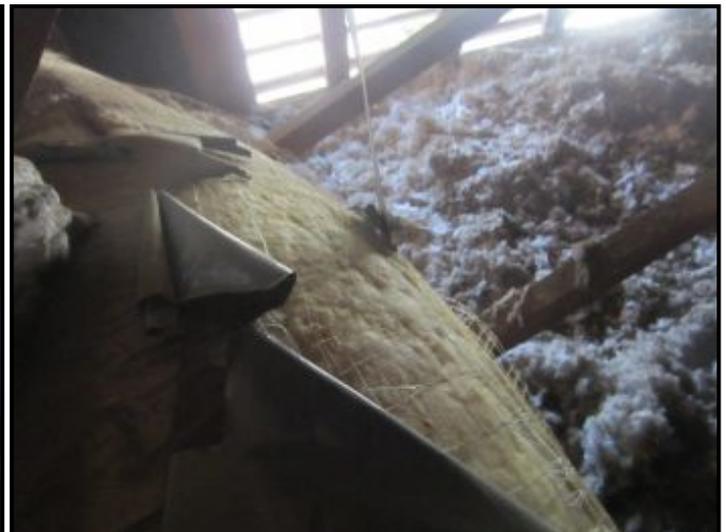
Wrapping is torn in areas.

Recommend review for repair or replacement as necessary.

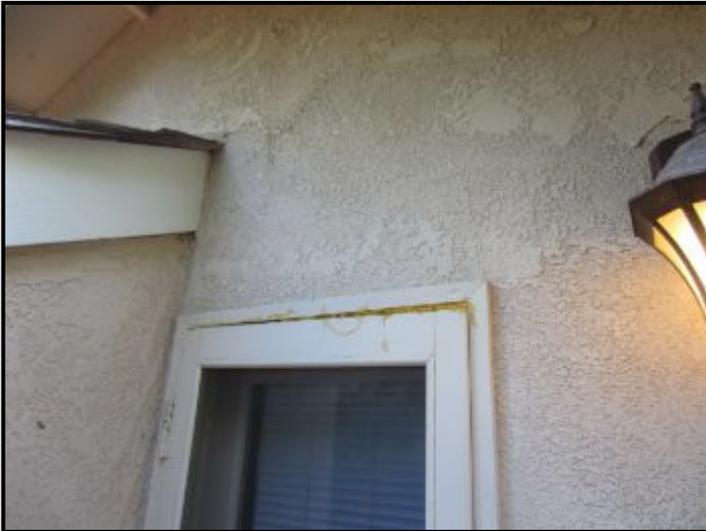
Bathroom exterior door with expanded foam seal

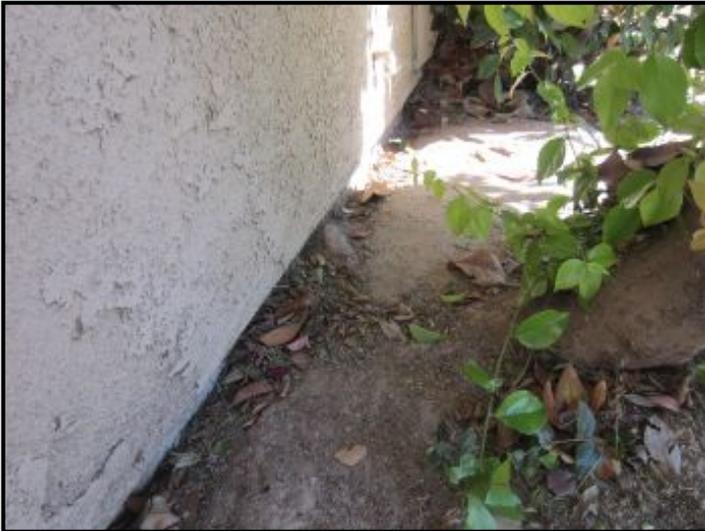
Maintenance Tip: When landscaping, keep plants, even at full growth, at least a foot (preferably 18 inches) from house siding and windows. Keep trees away from foundation and roof. Plants in contact or proximity to home can provide pathways for wood destroying insects, as well as abrade and damage siding, screens and roofs.

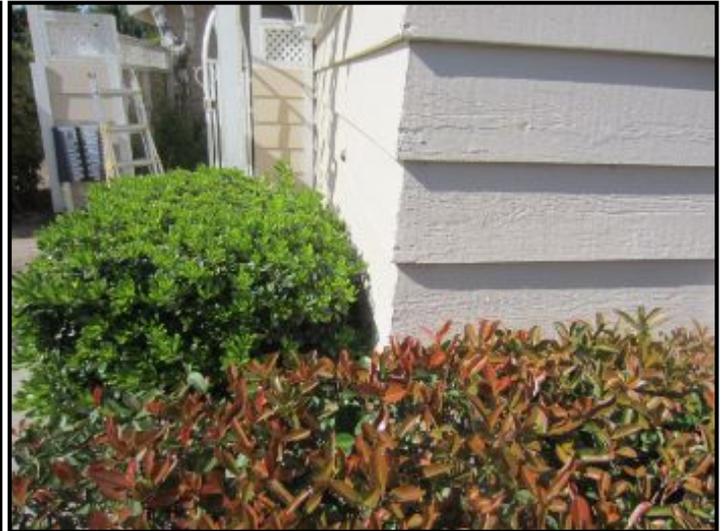
Maintenance Tip: When landscaping, keep plants, even at full growth, at least a foot (preferably 18 inches) from house siding and windows. Keep trees away from foundation and roof. Plants in contact or proximity to home can provide pathways for wood destroying insects, as well as abrade and damage siding, screens and roofs.
